The Honorable T. Bella Dinh-Zarr, PhD, MPH
Board Member
National Transportation Safety Board

Committee on Commerce, Science, and Transportation
United States Senate

Are We Ready for the Next Hurricane Season?
Status of Preparation and Response Capabilities for 2018

Washington, DC • April 12, 2018

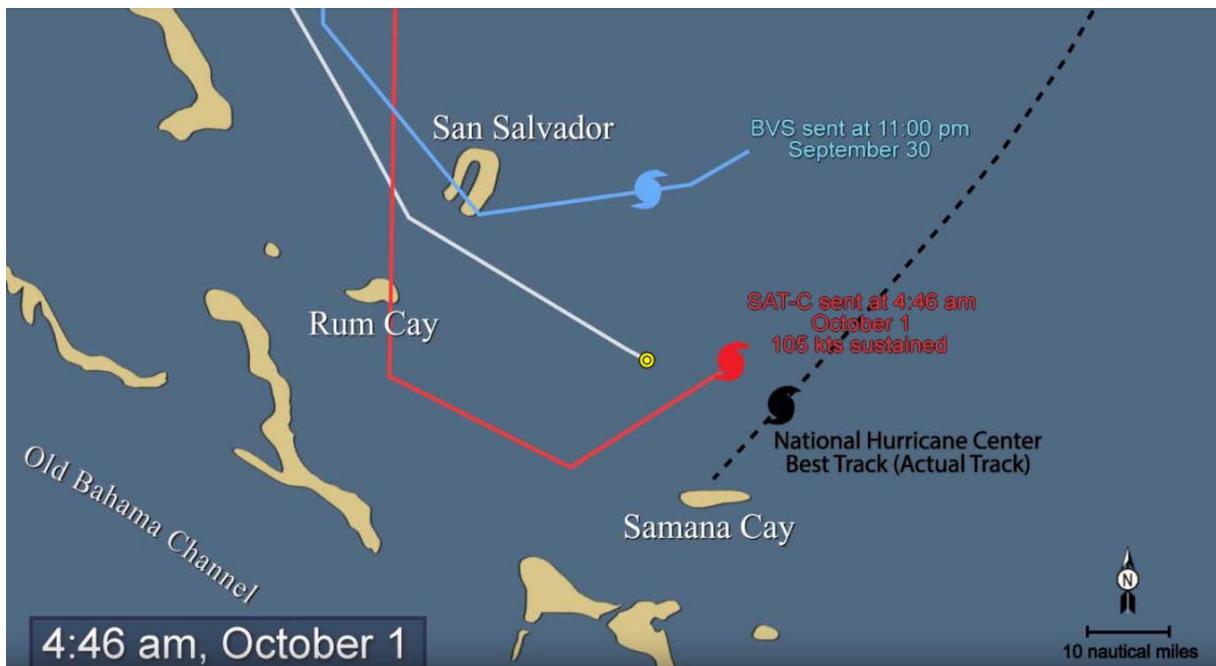
the captain to make educated decisions regarding the vessel's route, but the captain did not use it. Several times throughout the night of September 30 and into the early morning of October 1, the bridge crew noted their concerns about the ship's advancement toward a strengthening storm based on information from SAT-C and other sources; however, the captain may have felt confident about the ship's route and proximity to the storm. However, he was relying on BVS weather information that was many hours older than what the bridge crew was reviewing. Based on the information obtained from the VDR, it seems most likely that the captain did not realize that Sat-C was providing more current information than BVS.

At 4:45 a.m., on October 1, the captain downloaded a BVS weather file that had been sent to him at 11:04 p.m. the night before. Joaquin's position, forecast track, and intensity given in the file were consistent with the data in the advisory that had been delivered to the bridge via SAT-C almost 12 hours before, at 4:54 p.m. the previous afternoon. At 4:46 a.m., *El Faro's* SAT-C terminal received an advisory indicating that *El Faro* was 11 nm northwest of the storm center (**Figure 1**). By that time, the ship was experiencing a starboard list caused by increasing wind on the vessel's port side. As the ship continued to sail into the storm, the crew struggled to deal with a cascading series of events, including flooding and loss of propulsion, any one of which could have endangered the ship on its own.

Figure 1. *El Faro's* location in relation to available weather forecasts and poststorm analysis at 4:46 a.m. on October 1.
