*Testimony of*  
Jennifer Homendy  
Chairwoman  
National Transportation Safety Board

*Before the*  
Committee on Commerce, Science, &  
Transportation  
United States Senate

The NTSB Final Report on the DCA Midair Collision

Washington, DC • February 12, 2026

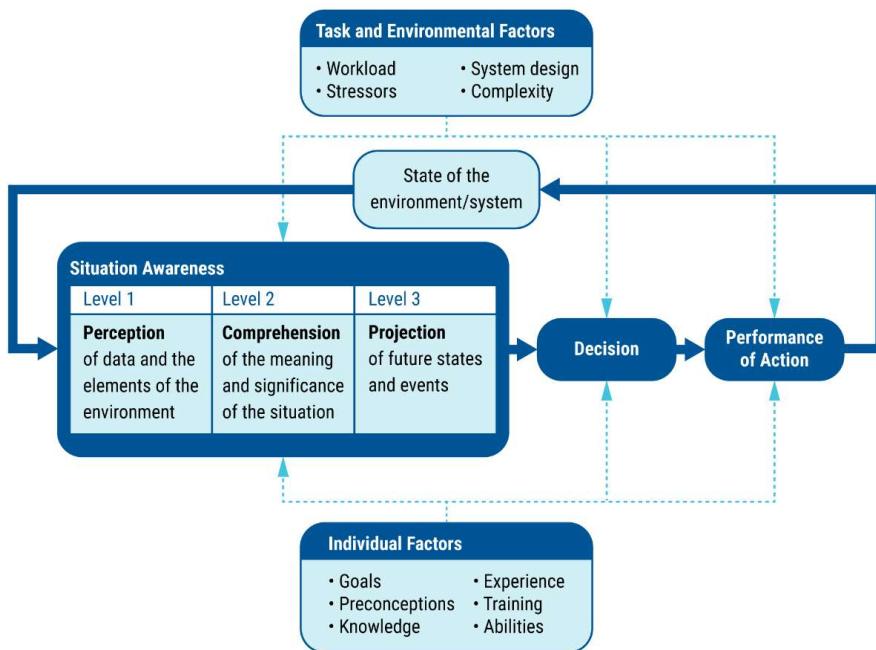
Situation awareness forms a basis for decision-making and is defined as the "perception of the elements in the environment within a volume of time and space [Level 1], the comprehension of their meaning [Level 2], and the projection of their status in the near future [Level 3]" (Endsley, 1988).<sup>2</sup> Figure 1 presents an illustration of the situation awareness concept. Situation awareness is not only what the controller is perceiving in the current air traffic situation (level 1) but how they interpret that information (level 2) and use it to project the future state of air traffic (level 3) moving in their airspace. Levels 2 and 3 are especially critical in the air traffic environment because it is dynamic and constantly changing.

**Figure 1.** Diagram of the situation awareness concept.
